Pavement Condition Survey Report – Year 2024

December 31, 2024

Prepared for:
City of Taylor, Texas
400 Porter Street,

Prepared by:
Applied Research Associates, Inc.
TBPE Firm Registration No. F-4631
2217 West Braker Lane
Austin, TX 78758

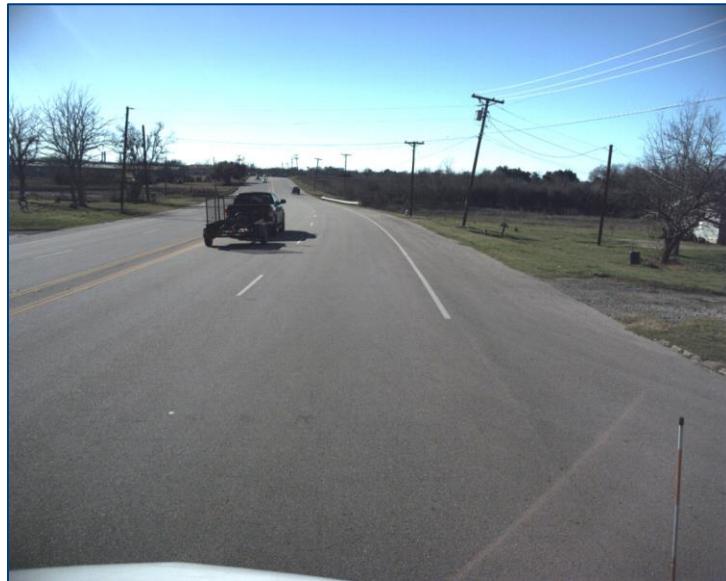
Figure 6. 4TH Street East, PCI = 95

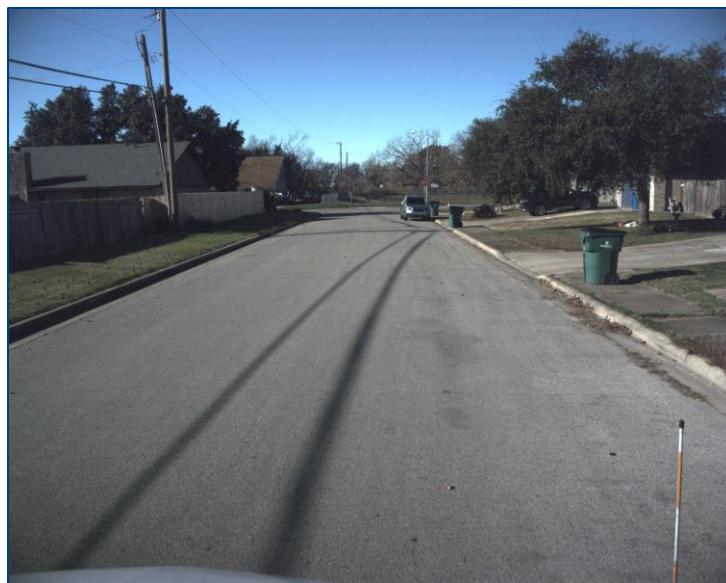
Figure 7. Boyer Drive, PCI = 80

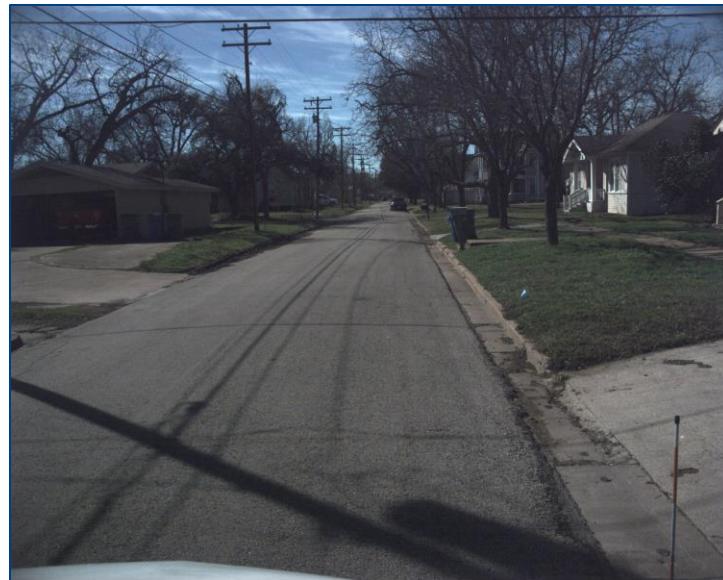
Figure 8. 10TH Street West, PCI = 69

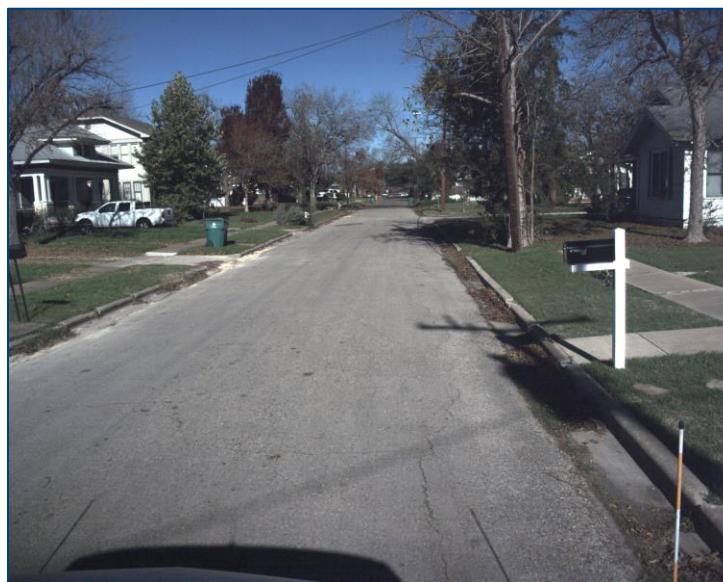
Figure 9. Lexington Street, PCI = 63

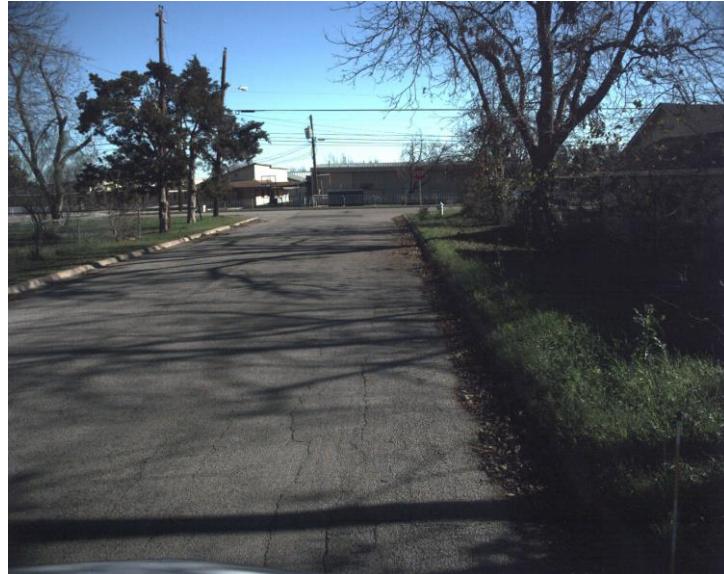
Figure 10. Marshall Street, PCI = 51

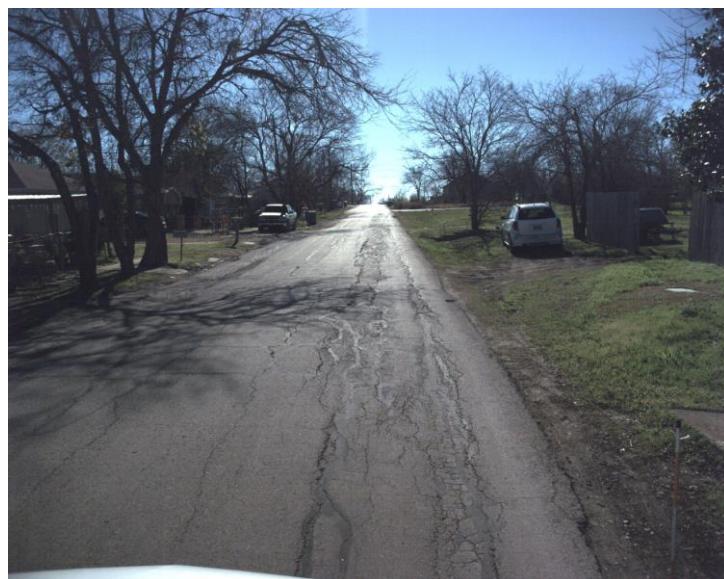
Figure 11. Burkett Street, PCI = 45

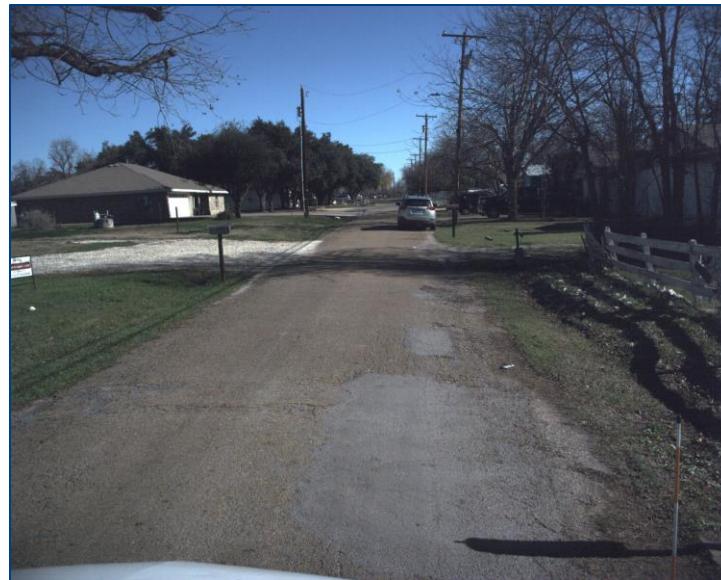
Figure 12. Hosack Street, PCI = 34

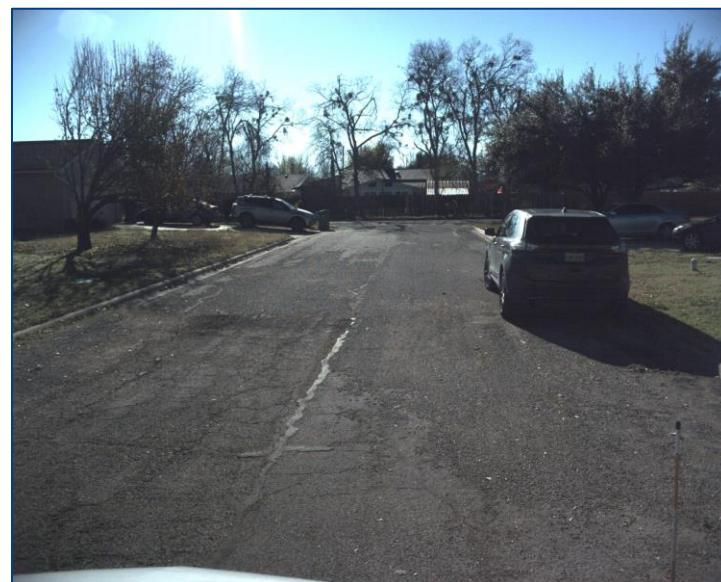
Figure 13. Lark Lane, PCI = 22

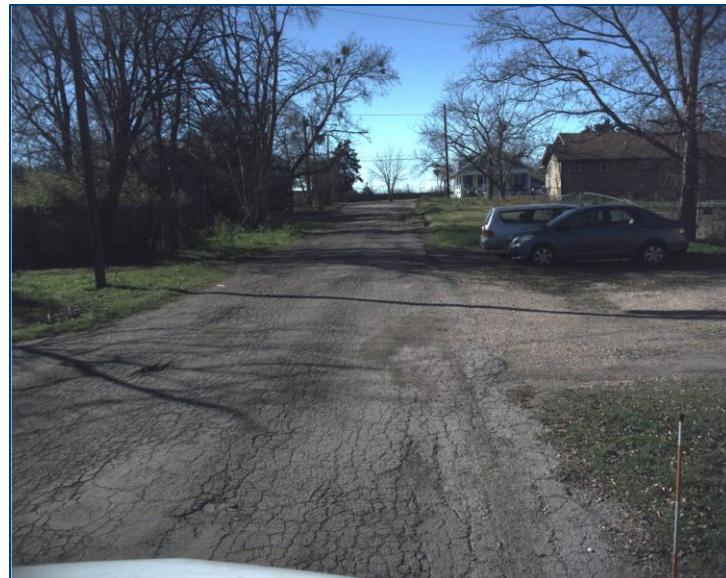
Figure 14. 6TH Street West, PCI = 8

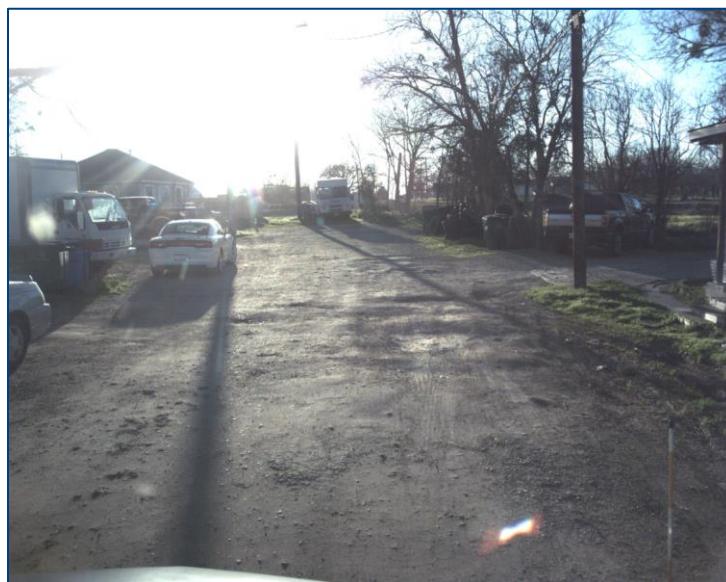
Figure 15. 2ND Street East, PCI = -1 (Gravel Roads)
