Pavement Condition Survey Report – Year 2024

December 31, 2024

Prepared for:
City of Taylor, Texas
400 Porter Street,

Prepared by:
Applied Research Associates, Inc.
TBPE Firm Registration No. F-4631
2217 West Braker Lane
Austin, TX 78758

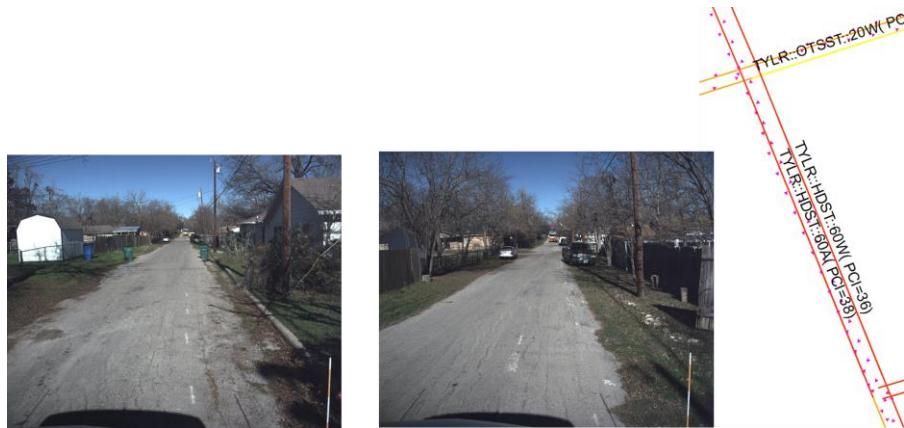
In narrow roads like alleys, multi-functional vehicles encounter substantial constraints when collecting images of pavement surfaces. These limitations arise primarily from the restricted space available for maneuvering. The narrow width of these alleys poses a significant challenge for the vehicle to efficiently capture pavement surface images in both driving directions. This scenario is exemplified in Figure 2.

Figure 2. Data Collections in Narrow Routes (Alleys)

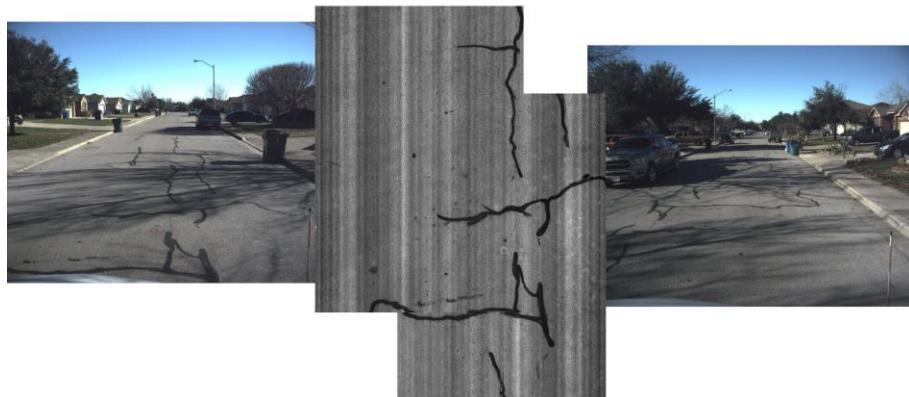
Additionally, the presence of parked vehicles along both sides of the road hinders the vehicle's movement, further impeding its ability to navigate freely. Consequently, the data collection process becomes one-directional, concentrating solely on one travel direction due to these spatial limitations. Figure 3 depicts a situation where surface images were collected in both directions despite the presence of parked cars on both sides of the road. However, due to the necessity to navigate around the parked vehicles, a substantial portion (more than 50% of intersections) of the captured images ended up duplicating the same location along both pathways.

Figure 3. Impacts of Parked Vehicles on both Sides of the Roads on Data Collection

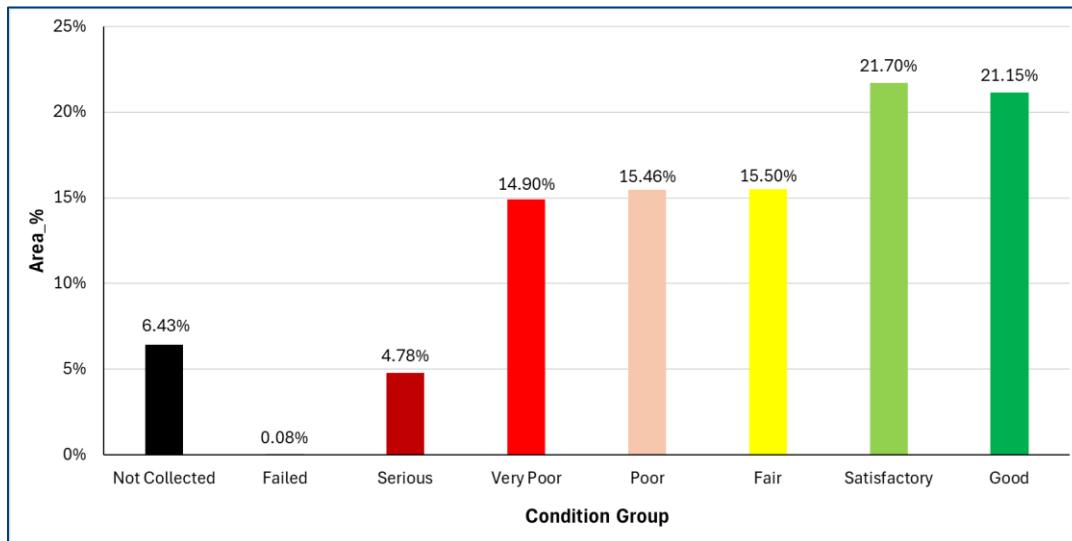
Table 1 and Figure 16 summarize the PCI for the City of Taylor, Texas, based on an ARA semi-automated distress survey. The results reveal the distribution of pavement conditions across various PCI ranges. The data indicates that 6.43% of the surveyed area, covering 188,407 SY, is categorized as "Not Collected". Only 0.08% of the area, equating to 2,340 SY, falls within the "Failed" category. A slightly larger portion, 4.78%, or 140,009 SY, is classified as "Serious" (PCI range of 10 to 25). The "Very Poor" and "Poor" categories account for 14.90% (436,962 SY) and 15.46% (453,307 SY) of the surveyed area. The "Fair" category (PCI range of 55 to 70) constitutes 15.50%. The "Satisfactory" category (PCI range of 71 to 85) covers 21.70% (636,233 SY), the second-largest proportion. Finally, the "Good" category (PCI range of 85 to 100) represents 21.15% of the surveyed area. The PCI score along with a PCI-based rank of all streets of City of Taylor is provided in Appendix A.

Figure 16. PCI Pavement Condition Distribution by Area

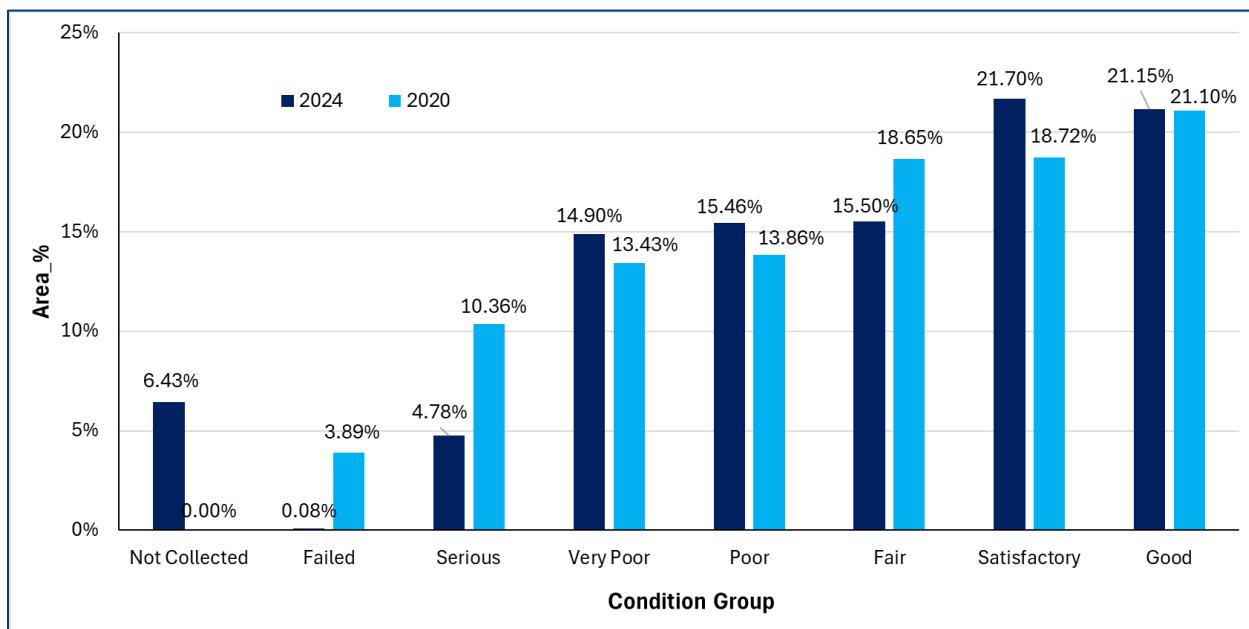
The comparison of pavement conditions between 2020 and 2024, based on PCI ranges and area percentages, highlights notable changes in distribution. The "Failed" category (PCI range 0 - 10) experienced a significant reduction, dropping from 3.89% in 2020 to 0.08% in 2024. Similarly, roads in "Serious" condition (PCI range 10 - 25) decreased from 10.36% (291,672 SY) to 4.78% (140,009 SY), reflecting substantial improvement.

Conversely, there was a slight increase in the "Very Poor" and "Poor" condition categories, rising from 13.43% to 14.90% and from 13.86% to 15.46%, respectively. The "Fair" category declined from 18.65% (525,146 SY) in 2020 to 15.50% (454,580 SY) in 2024. However, improvements were observed in the "Satisfactory" and "Good" condition categories. The "Satisfactory" category increased from 18.72% to 21.70%, while the "Good" category grew slightly from 21.10% to 21.15%. These shifts indicate an overall improvement in pavement conditions, with a focus on addressing the most critical areas.

Figure 17. 2020 & 2024 Condition Surveys

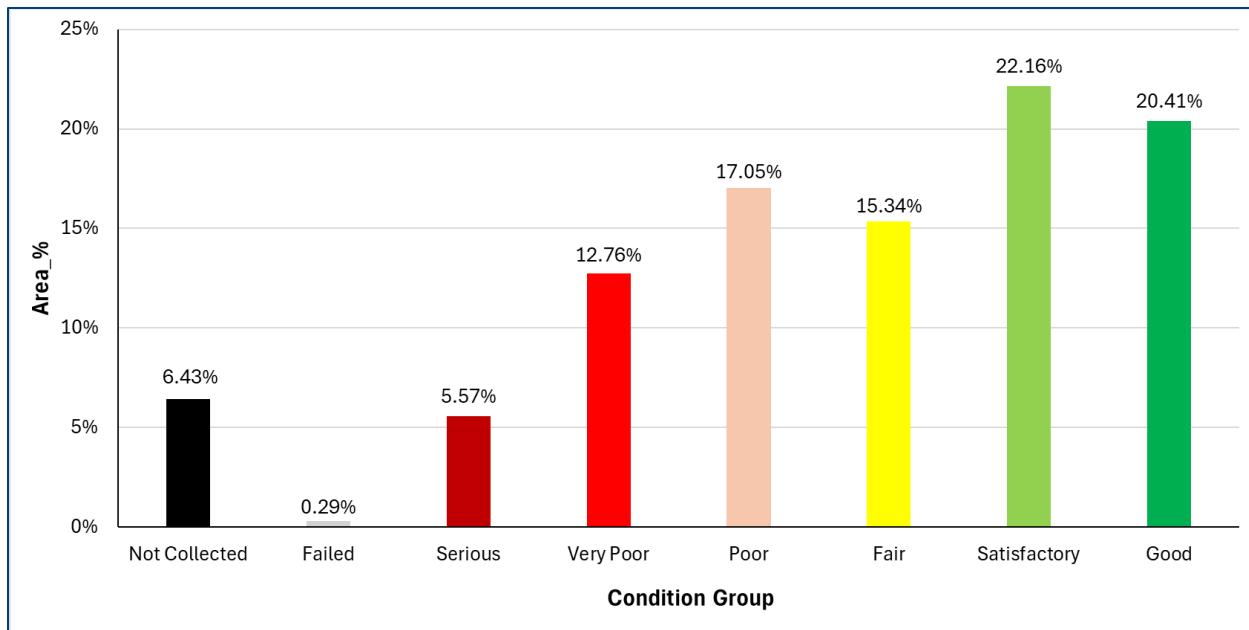
Table 2 illustrates the distribution of OCI condition categories based on the percentage area and length they cover in the city of Taylor. The majority of the area falls under conditions ranging from "Good" to "Fair," with "Satisfactory" being the most prevalent at 22.16% of the area, followed closely by "Good" at 20.41%. The "Fair" condition category covers 15.34% of the area, while "Poor" and "Very Poor" conditions collectively account for 29.81% of the area. Specifically, "Poor" covers 17.05%, and "Very Poor" covers 12.76%. The remaining categories, including "Serious," "Failed," and "Not Collected," represent smaller proportions of the total area, with "Serious" covering 5.57%, "Failed" at 0.29%, and "Not Collected" at 6.43%. The OCI scores of all city-maintained streets are presented in Appendix B. The rank of each pavement section based on the OCI value relative to the remaining pavement sections is presented in Appendix B.

Figure 18. OCI Pavement Condition Distribution by Area

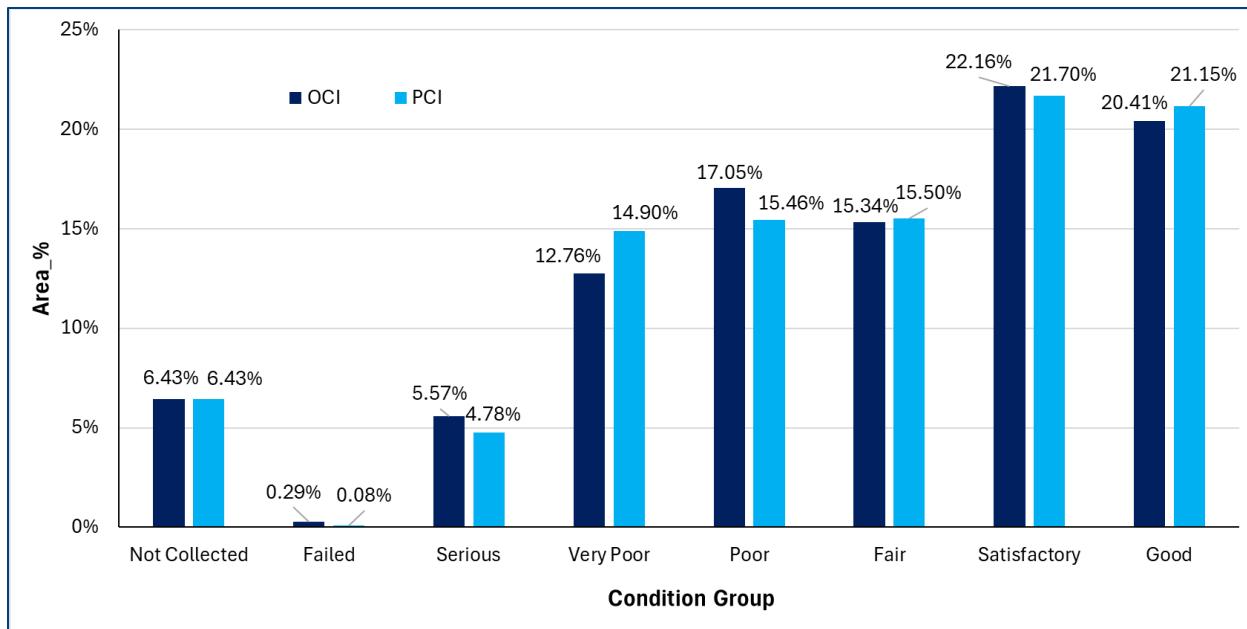
Figure 19 compares the percentages of areas classified into different condition groups based on the Pavement Condition Index (PCI) and the Overall Condition Index (OCI). The condition groups range from Failed to Good, with OCI percentages generally higher in poorer condition categories and lower in better condition categories compared to PCI. In the Failed and Serious groups, the area percentage increased significantly, indicating the impact of including pavement surface roughness in the condition score.

Figure 19. PCI and OCI Comparison
